The Spotted Owl (Pty) Ltd
3 Neutron Road
Neutron House
Techno Park
7600

Subject: Gas Leak Repair

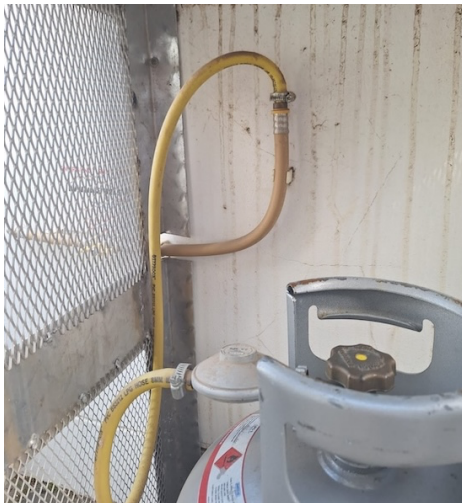
We are asked to assist with a gas leak. What we found was a non-compliant installation with a leak in the (non-compliant) flexible hose attached to the bullnose regulator on the geyser (see figure below)

The immediate requirement was for fixing the leak and providing a report. To fix the leak in a safe manner we replaced the bullnose and flexible pipe with the appropriate low-pressure regulator and pigtail assembly set.

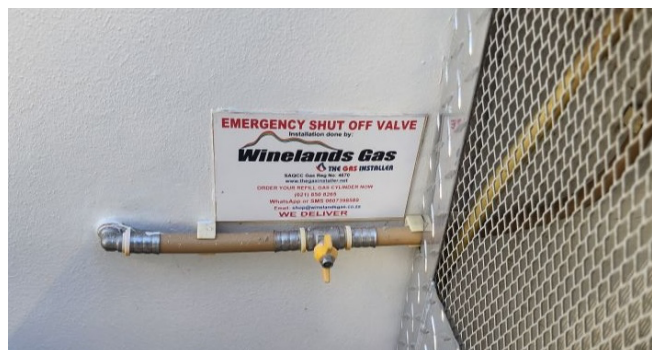
1. The connection to the gas bottle on a fixed installation was made with a flex hose and bullnose regulator.
2. The Pex-Al-Pex pipe used outdoors were not protected with a UV-resistant covering such as PVC pipe. It is a very short section but should still be covered
3. It doesn't appear as if the Pex-Al-Pex pipe is sleeved where it goes into to house through the wall.
4. Appropriate safety signage was not on display next to the cage and shut-off valve
5. No shut-off valve inside the house in the cupboard next to the stove. This is not a compliance problem but a recommendation for good practice.
